## Action Log Report

Coastal GasLink Pipeline Site 532, unnamed tributary (Morice River), Houston  
Habitat File No:

## **2020 Spawning Survey Summary – Morice River (Site 558), Construction Section 7**

### **Work Package 3**

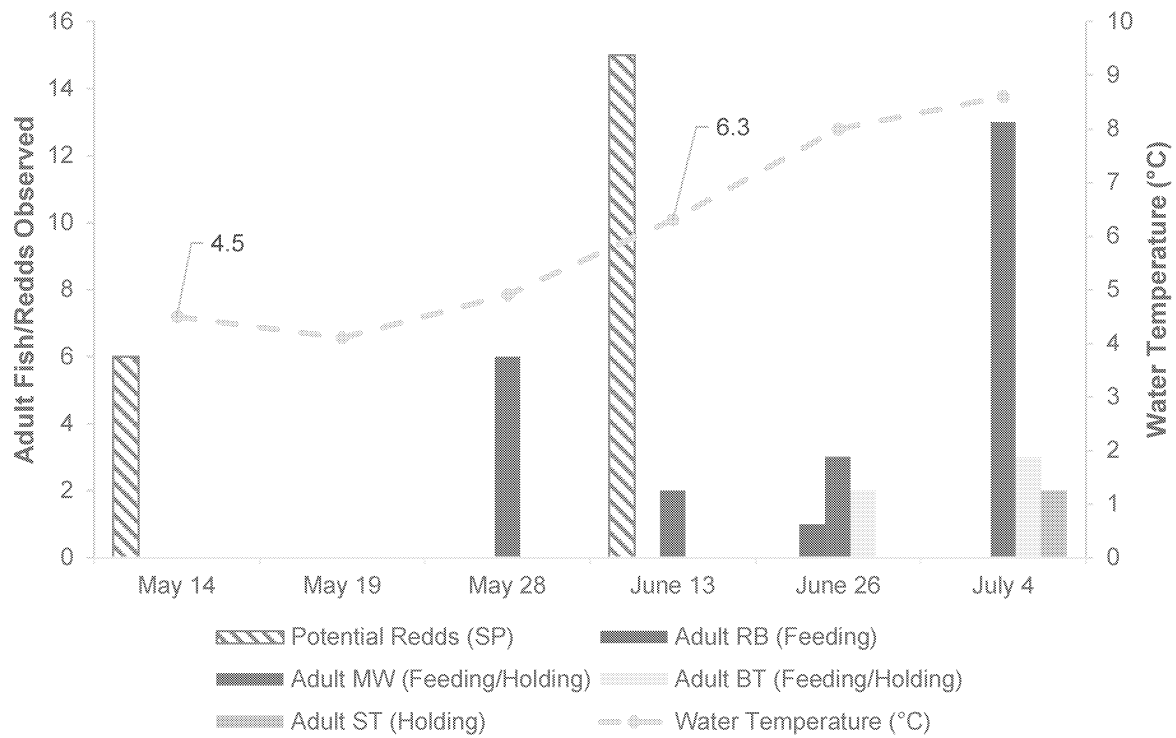
**Figure 2. Adult Sportfish Activity and Redd Observation Summary for the Site 558 2020 Spring Spawning Surveys**

There were six spring spawning surveys conducted between May 14 and July 4, 2020 at Site 558. During these surveys, visibility was generally high with low turbidity. Water temperature ranged from 4.1 degrees Celsius (°C) to 8.6°C, pH from 7.3 to 8.5, and dissolved oxygen (DO) from 8.0 milligrams per litre (mg/L) to 10.0 mg/L. No spawning behaviour was observed, however, 21 potential redds were observed (see Table 2 and Figure 2). Since no adult spring spawning fish were observed with these redds, they were recorded as potential redds. The potential redds ranged in size from 0.1 m by 0.2 m, to 0.5 m by 1.5 m. Based on the size range, the smaller potential redds may have been created by RB and the larger redds by ST, since these were the only spring spawning redd-building species observed during the spring survey period. General fish observations included BT, BT/DV, CC, CH, CO, MW, RB, SA, SP, and ST (see Table 2 and Figure 5). The SP observed were unidentified salmonids.

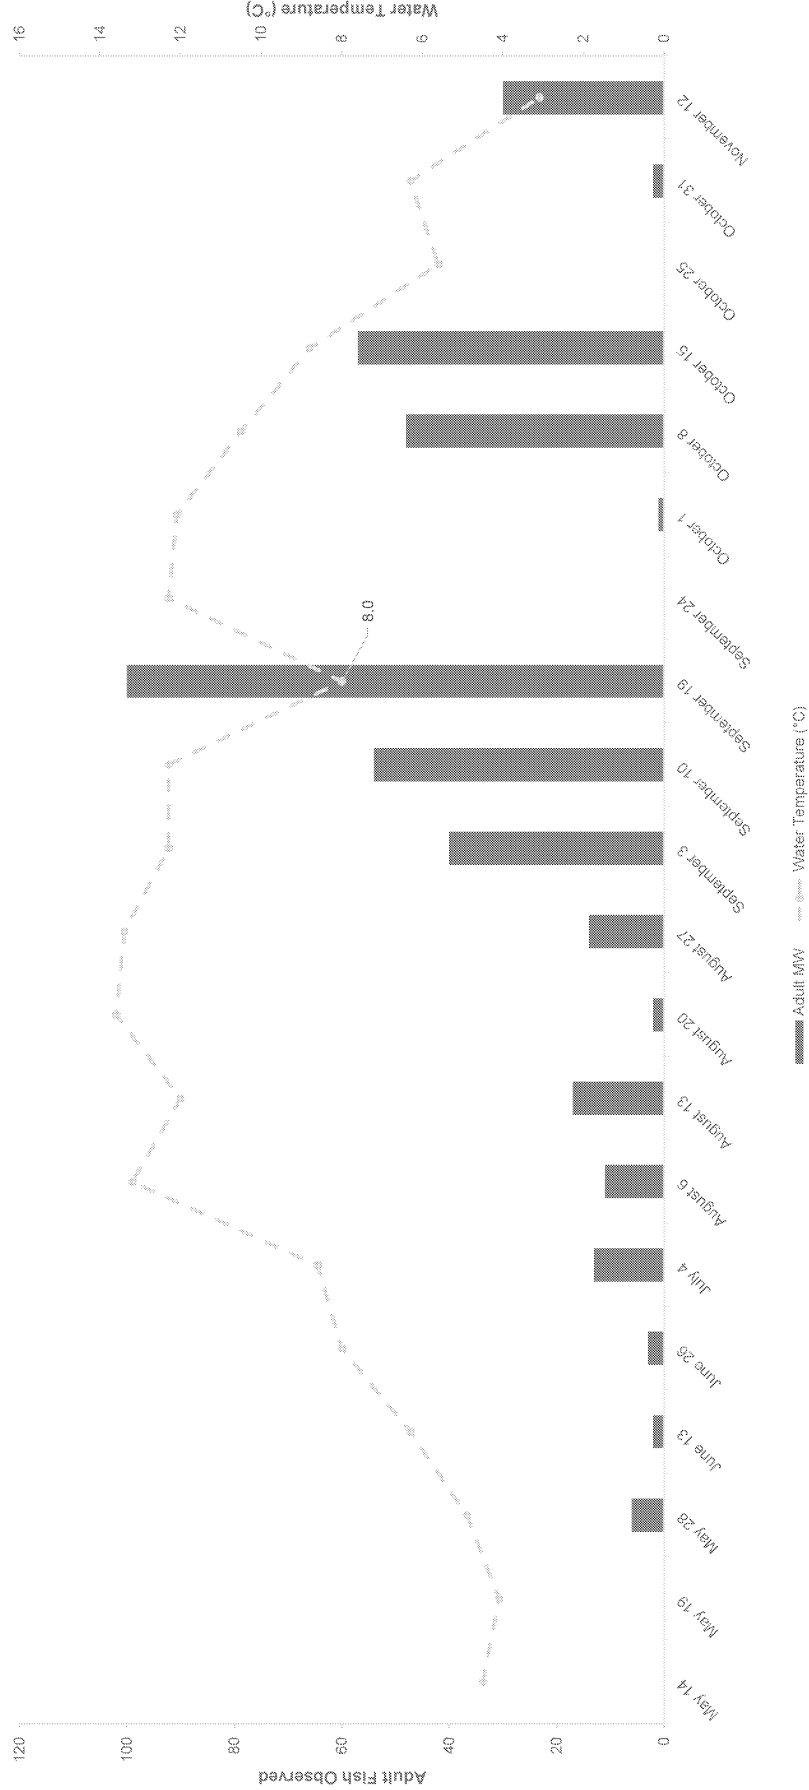
Figure 4. Adult Mountain Whitefish Observations During the Site 558 2020 Spawning Surveys

During the 2020 fall spawning surveys, MW were regularly observed throughout the study reach and groups of MW were frequently observed feeding and holding u/s and d/s of the construction footprint. Although congregations of adult MW (that is, 10 or more fish grouped together tightly and behaving in a way that suggests they are maintaining that grouping) were not observed during the surveys, a large number of the adult MW observed were consistently in a deep run/pool section approximately 260 m upstream from the construction footprint, and in a deep pool approximately 110 m downstream from the construction footprint (see Figure 1). Adult MW observations generally increased from the spring into fall and peaked on September 19, 2020, when water temperature was 8.0°C (see Table 2 and Figure 4). MW are broadcast spawners that release eggs over the substrate without site preparation, often spawning at dusk or during the night. These factors make it difficult to observe and confirm MW spawning. Spawning typically begins when water temperature drops below 10°C and peak activity occurs at temperatures less than 6°C (McPhail 2007).

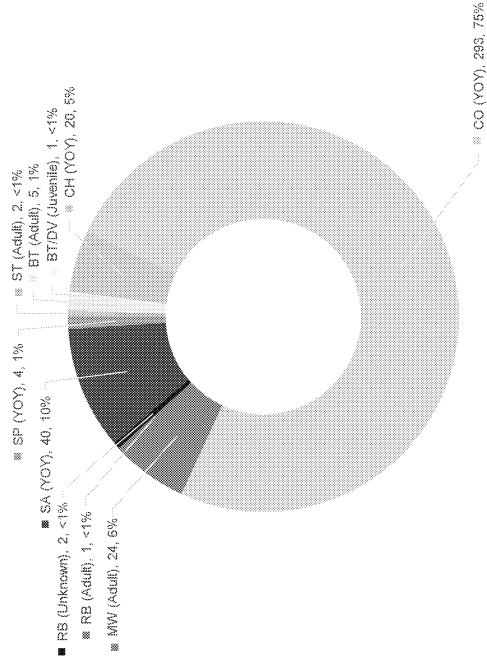
Figure 5. Sportfish Observation Summary for Site 558 2020 Spring Spawning Surveys (May 14 to July 4)  
(Species [Age Class], Count, Percentage)

Spawning habitat was identified both within and outside of the construction footprint at the Morice River near Site 558. Spring and fall survey effectiveness was limited in the main channel due to high flow, instream hazards, and large channel size, so survey efforts were focused on the slower-moving side channels and channel margins. No spawning behaviour was observed during the spring spawning surveys, however, potential redds were observed within, u/s, and d/s of the construction footprint (see Figures 1 and 2, and Table 2). RB and ST were the only adult spring spawning redd-building species observed during the surveys (see Figure 5).
